FIBER OPTIC DAMAGE ASSESSMENT SYSTEM FOR FIBER
REINFORCED PLASTIC COMPOSITE STRUCTURES*

Roger M. Crane and Aleksander B. Macander

November 1982

SME-82/92

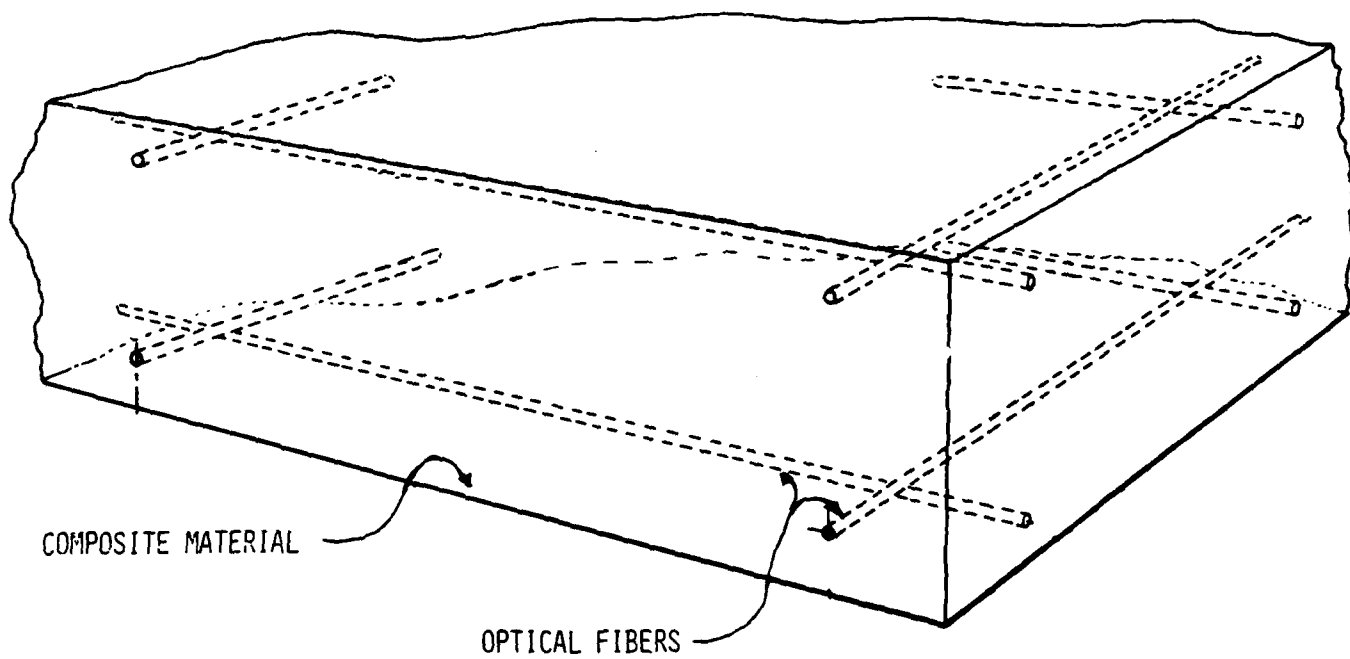
FIGURE 1: SCHEMATIC OF A SIMPLE OPTICAL FIBER MESH USED FOR IMPACT TESTING

The type of failure to be detected, dictates the positioning of the optical fiber mesh. For this case, two orthogonally oriented sets of optical fibers will be used, one near each surface of the plate (Figure 1). The two sets of orthogonally oriented fibers will be nested within the laminae or plies of composite material during the fabrication process. The grid density or spacing of the optical fibers in a mesh can be designed to allow for more or less sensitivity depending on expected load conditions and resulting damage in various areas of the structure. It is anticipated that for large structures a dense grid represented by 1/2-in. fiber spacing should suffice in the highly loaded areas prone to damage while a looser grid of 1-in. would probably be adequate for the lightly loaded areas less likely to see damage.

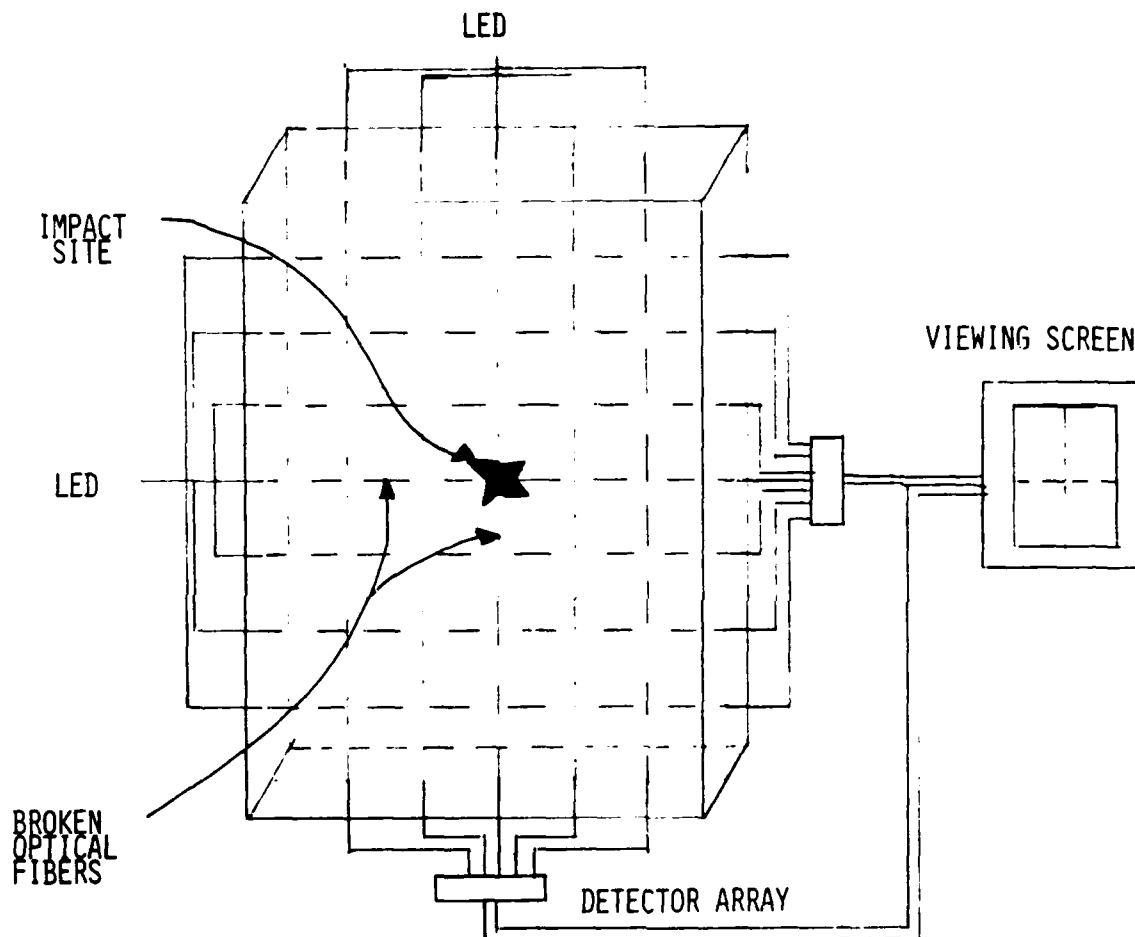
Figure 2: Schematic Of An Optical Fiber System In a Composite Plate Showing Impact Damage

Figure 2 illustrates a drawing of a panel which was impacted at its center. If the impact was severe, causing composite fiber failure, the optical fibers should likewise fail and prevent passage of light through the fiber. The detectors, sensing this condition would display this on a viewing screen, showing the location of the broken fibers within the structure. Since fibers are positioned in an orthogonal array, the location of the damaged area is known, being the intersection of the broken optical fibers. Hence, the system is capable of locating the damage and indicates severity as function of area and depth due to the placement of optical grids at various planes in the thickness of the composite. With incipient fiber breakage, the system would appear to be no longer operative. However, this is not the case as damage growth can still be monitored on a continuing basis since adjacent composite fibers would continue to fail thus resulting in additional optical fiber failure.

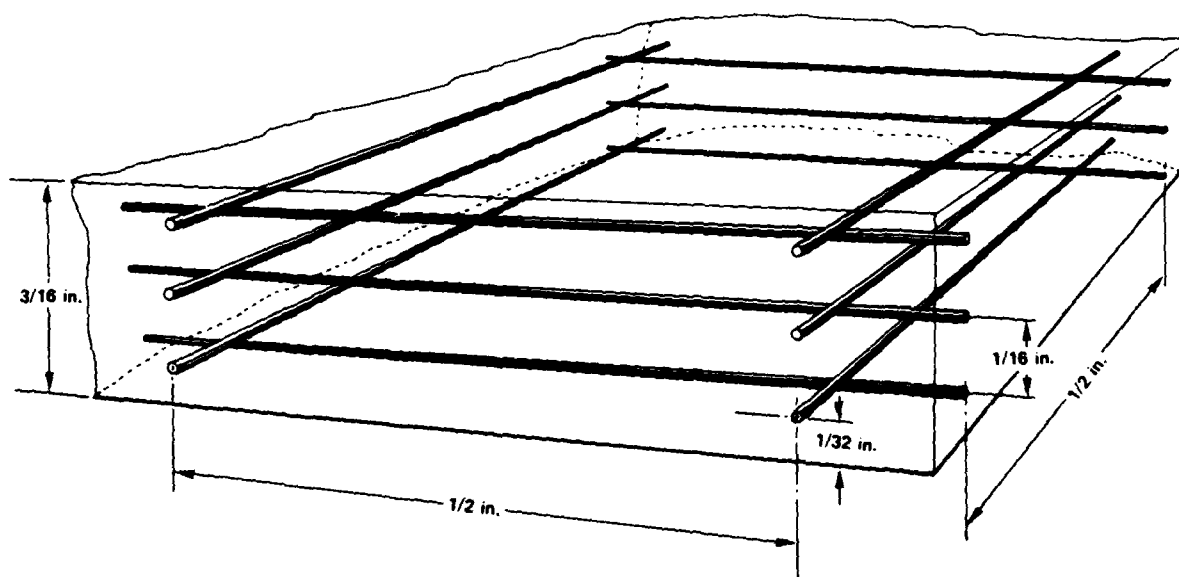
Figure 3: Narmco T-300/5208 Optical Fiber Schematic

after the impact loading. The optical fibers were placed on the 6th, 7th, 21st, 22nd, 33rd, 34th plies respectively parallel to the fibers in the laminate at a 1/2-in. spacing. A schematic of the fiber positions is given in Figure 3. With the optical fibers in place, the panels were processed using a vacuum bag/autoclave cure cycle suggested by the manufacturer.

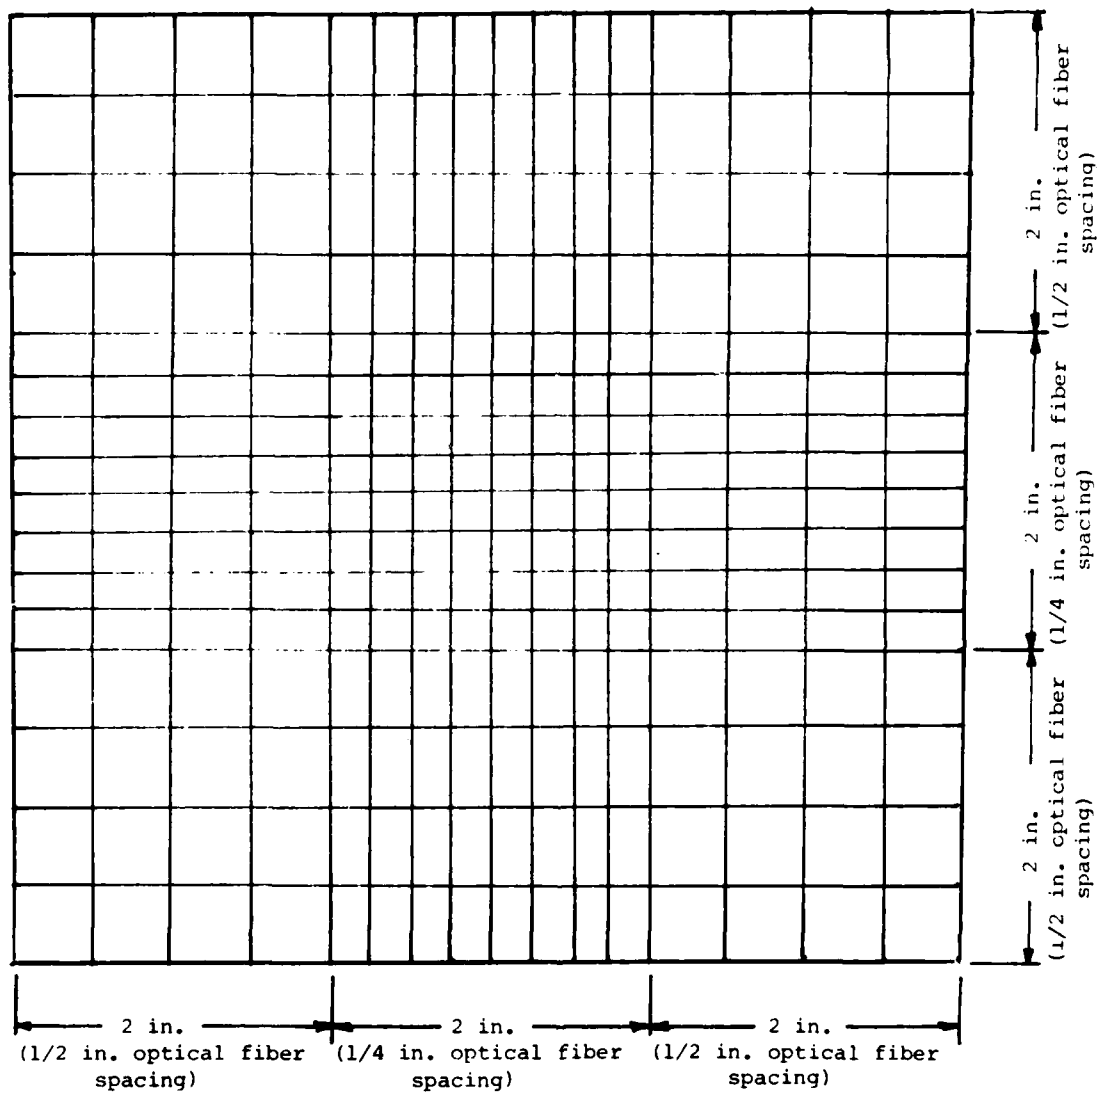
Figure 4 - Optical Fiber Mesh Spacing For Hexcel F-155 Panels (top view)

The Hexcel material is an E-glass, eight harness satin fabric impregnated with an epoxy resin. Three different composite/optical fiber geometries were fabricated. All panels were either 1/8- or 1/4- x 6- x 6-in.. The optical fibers were placed in each direction at 1/2-in. spacing for a distance of 2-in. from each edge of the specimen. The center region of the panel, measuring 2- x 2-in., had optical fibers spaced 1/4-in. apart. This closer spacing was used to obtain a more positive indication of the damaged region due to more optical fiber failures. A top view of the fiber spacing is shown in Figure 4. The first panel with the fabric arranged in a 0/90 orientation consisted of 13 laminae and was approximately 1/8-in. thick. Optical fibers were placed on plies 3, 6 and 10 in the 0° direction and 4, 7, and 9 in the 90° direction. The second panel consisted of 26 plies having optical fibers on plies 3, 6, 10 16, 19, and 23 in the 0° direction and 4, 7, 9, 17, 20, 22 in the 90° direction. This panel was approximately 1/4-in. in thickness. The third panel consisted of 25 plies of prepreg fabric with optical fibers on plies 5, 12, and 20 in the 0° direction and on plies 6, 13, and 19 in the 90° direction again with a laminate thickness of approximately 1/4-in. The same curing procedure was applied to this material as to the Narmco material.
